REPORT 250

**EXPERIENCE OF SUPERSONIC  
FLYING OVER LAND IN  
THE UNITED KINGDOM**

This Report was presented at the Fifteenth Meeting of the Flight Test Techniques and Instrumentation Panel, held 21-23 September 1959, in Aachen, Germany

This report describes the tests made to measure the intensities of supersonic bangs over land, and the extent of damage that can be caused by such bangs.

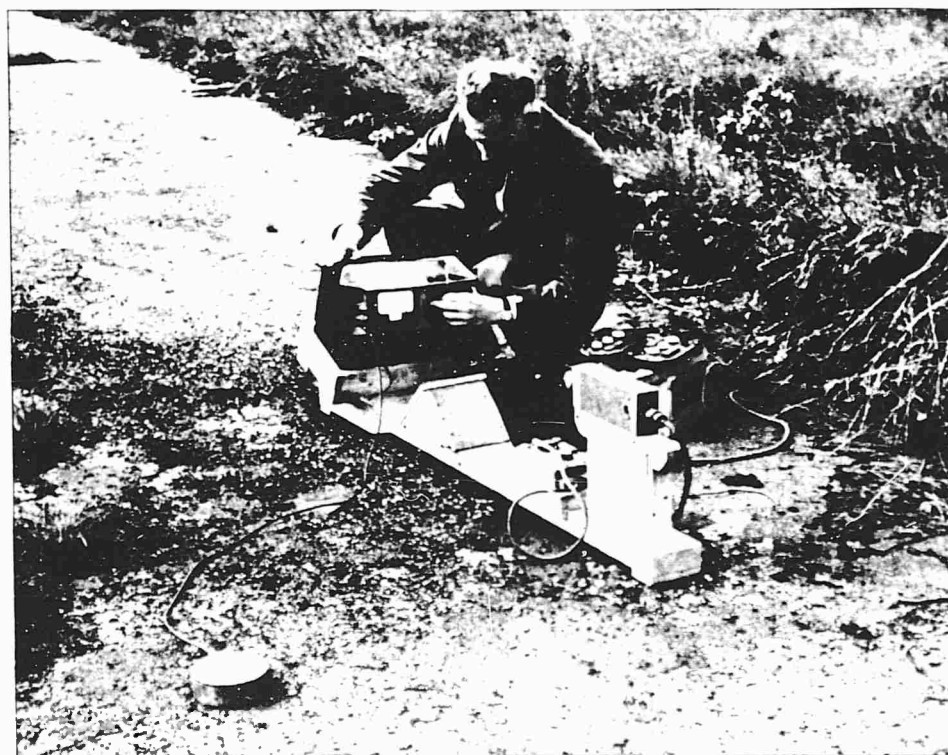
Fig.2 Installation of the piezo-electric gauges in the second series of tests

In the first series of tests, conducted by the Aeronautical Department of the Royal Aeronautical Establishment, a condenser type microphone was used and the incident pressures were measured by the changes in capacity and therefore changes in frequency of the gauge oscillator. The microphones were positioned with their diaphragms horizontal and about 10 in. above ground level (Fig.1). In the second series of tests, conducted by the Building Research Station, piezo-electric gauges were used as the pressure transducers. Some magnification of the load on the piezo-electric crystals was obtained by designing a light stiff diaphragm to receive the incident pressure and transmit the load to the crystals. A photograph of one of these pressure transducers and its position relative to the ground is shown in Figure 2.

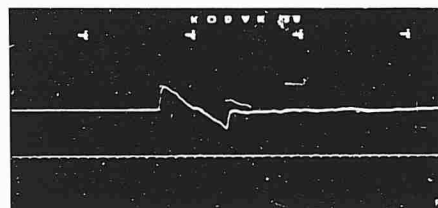
RUN No.49 DULL BOOM HEARD  
 HEIGHT 26,950 feet  
 M. 1.47

+0.87<sup>↑</sup> -0.73<sup>↑</sup>  
 lb/ft<sup>2</sup> lb/ft<sup>2</sup>

Fig.3 Some pressure recordings obtained during the first trials

A bang was always heard when the rate of pressure rise was sufficiently large, i.e. not less than about 100 lb/sq ft/sec. In well defined 'N' waves the minimum peak to peak duration observed was 0.06 secs and this was associated with a double bang being heard. In other cases dull booms were heard; these seem to be associated with a pressure-time wave which has a rounded off positive peak and a low rate of rise of pressure from the negative peak (run 6 Fig.3).

The very loud bangs (run 44 Fig.3) were similar in sound to close gunfire; a distinct pressure was felt on the chest and the ears were left momentarily ringing and there was a distinct impression that the ground shook. Even though the arrival of the bangs was expected within a second or so, the occurrence of the high intensity bangs was still startling. Table 1 summarises the effects of the bangs and physiological sensations and damage during the tests.

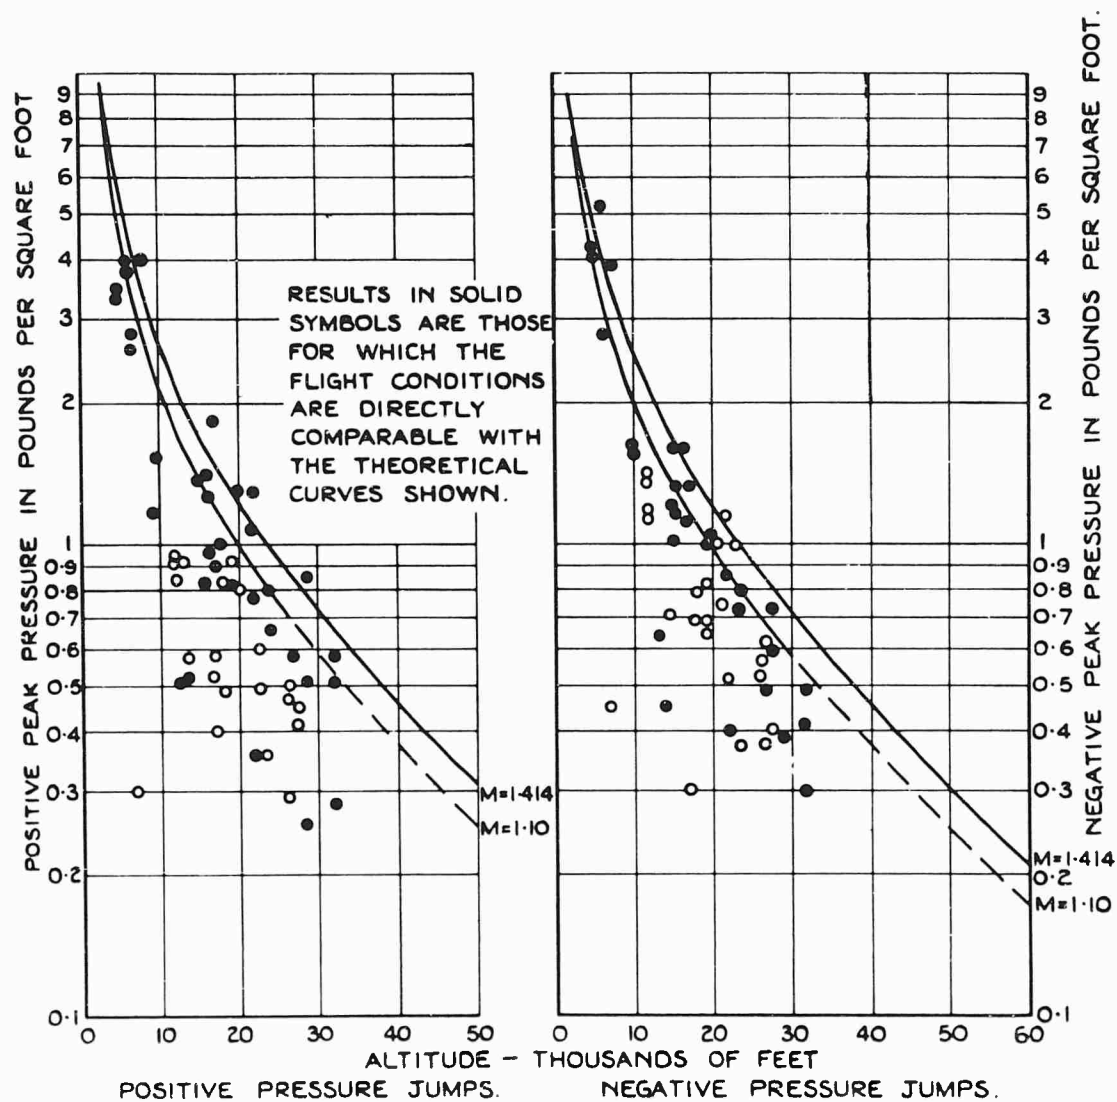
Fig.4 A comparison of the observed peak bang pressures with the theory of Warren for steady level flight

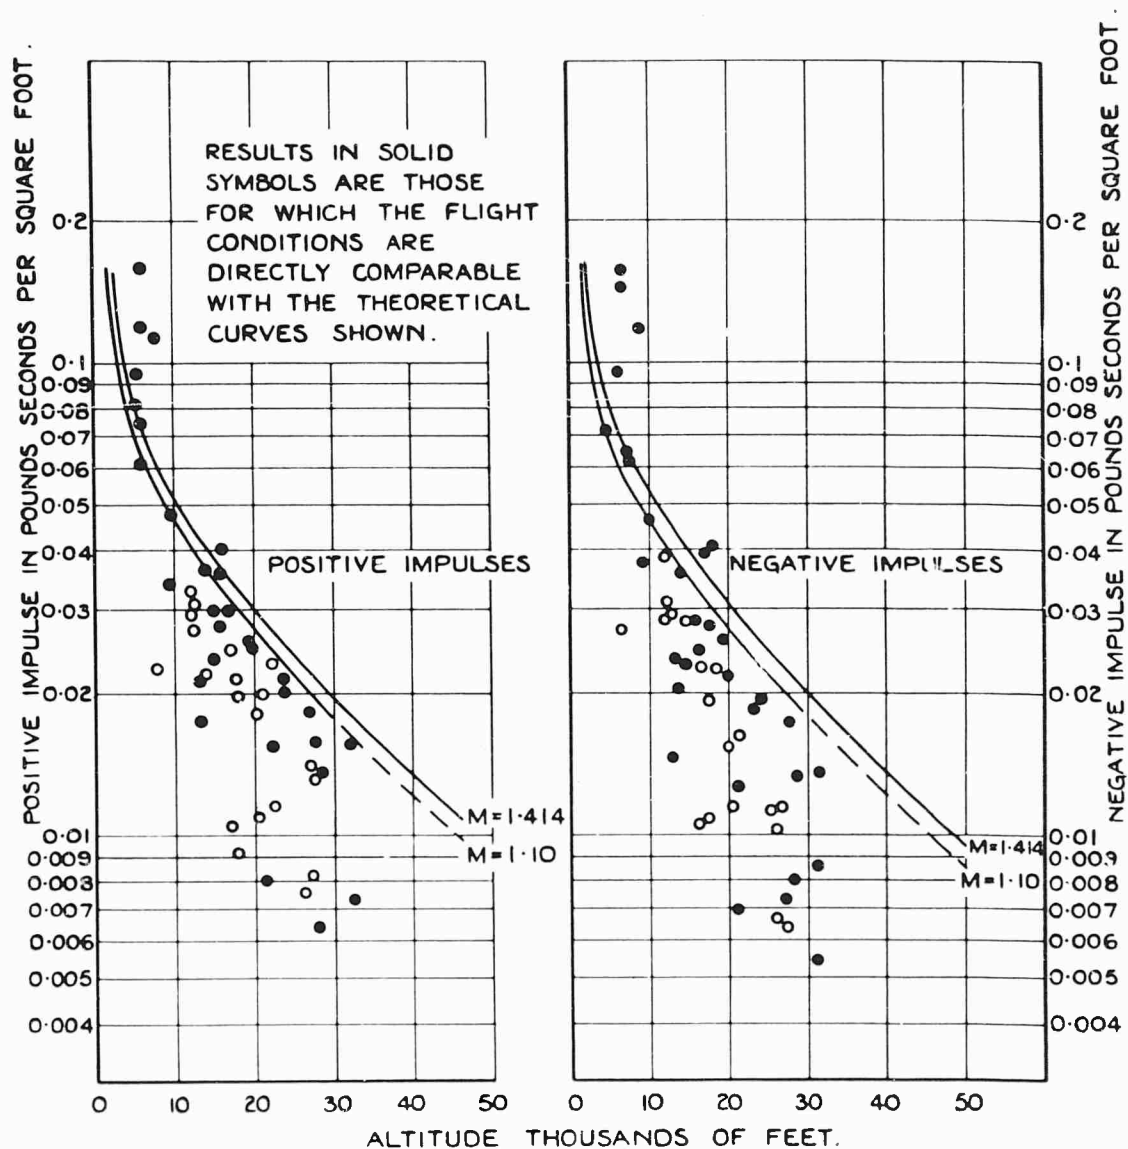
Fig.5 A comparison of the observed bang impulses with the theory of Warren for steady level flight

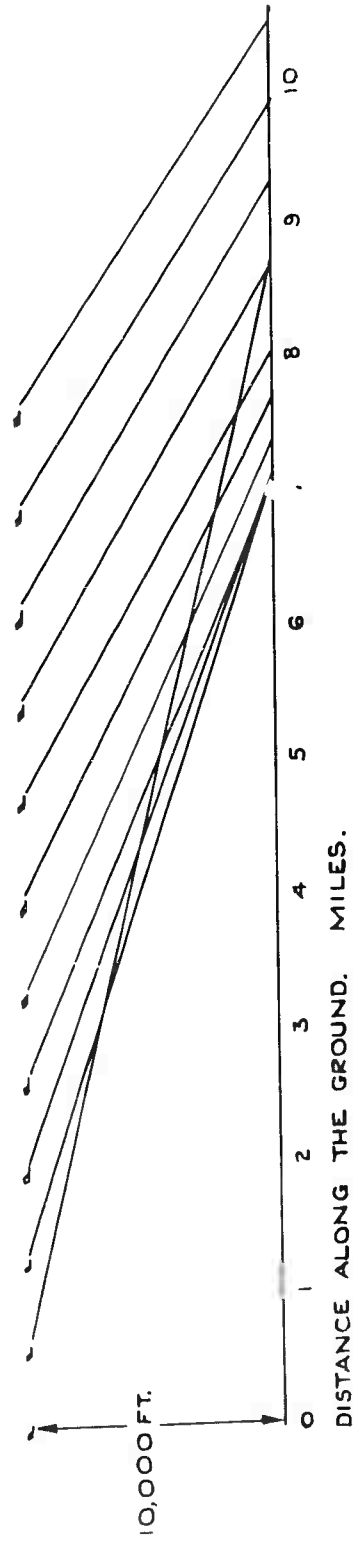
TIME, SECS.	0	3	6	9	12	15	18	21	24	27	30	33
MACH. N°	0.98	1.024	1.050	1.069	1.091	1.111	1.131	1.148	1.160	1.171	1.184	1.194

Fig. 6 A pictorial presentation showing the line of propagation of the wave fronts at each aircraft position

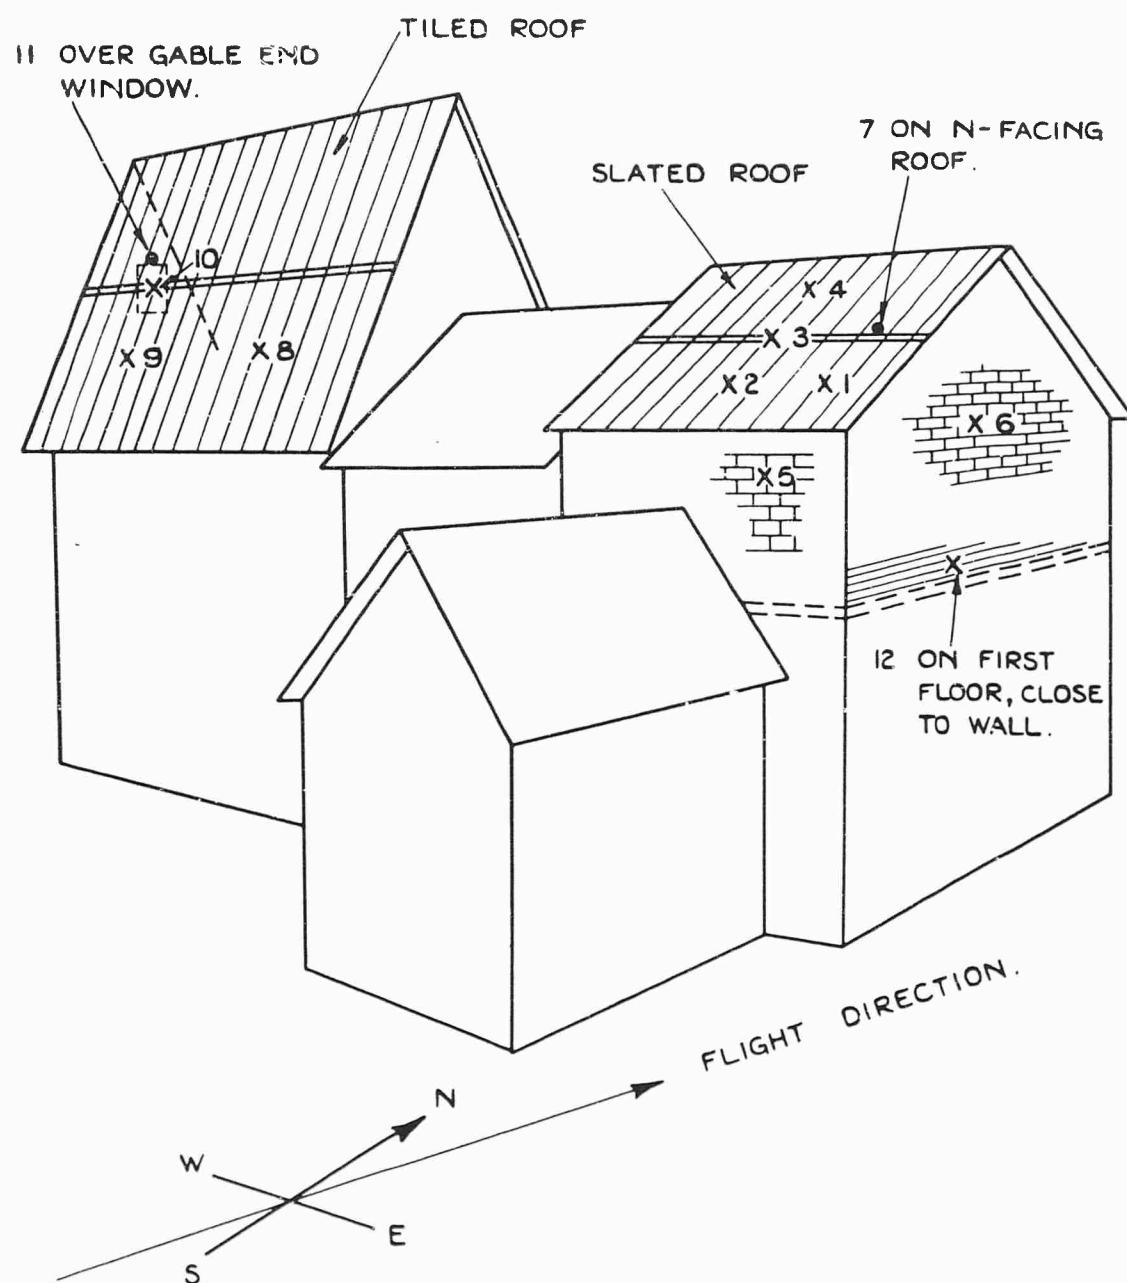
Fig.8 Positions at which vibration measurements were taken on houses

The effect of these bangs on the roof structure of some houses was measured by the Building Branch Station. The type of building used in the test is shown in Figure 8 and typical accelerometer records obtained are shown in Figure 9. The average acceleration measured normal to the roofs facing the bang was 0.7 'g' and the average peak to peak displacement was 0.040 in. The peak values measured during the test were 1.0 'g' and 0.087 in. respectively.

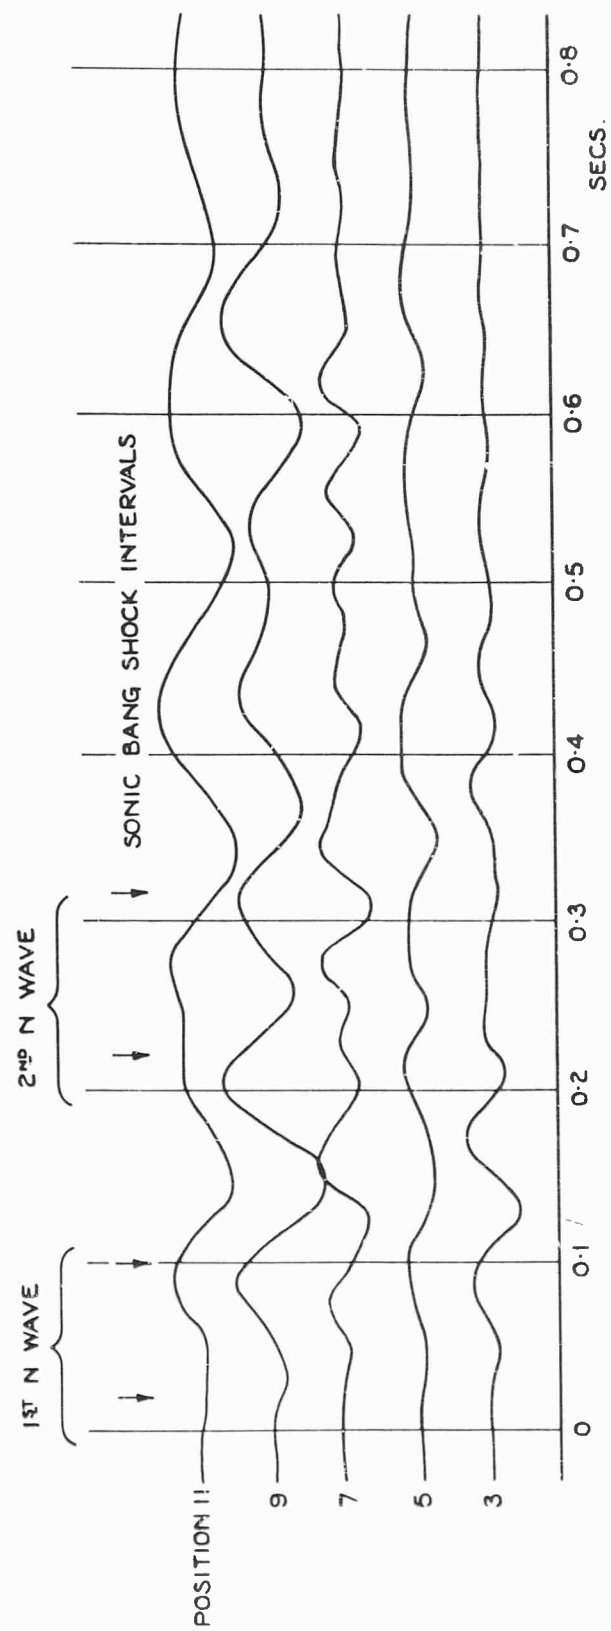
Fig. 9 Building vibration amplitude records
